**Flood Control Project Maintenance
Levee Inspections**
LMA District Cover Sheet
Spring 2017 Levee Inspection Results

Eastern Honcut Creek

Unit Cover Sheet

Waterway			Bank	Unit Miles
Unit No. 01 Van Tress			Left	1.46
	Spring (March - May)	Summer (June - August)	(September - November) Fall	Winter (December - February)
Unit Maintenance Rating (Fall Only)				
Date of Inspection	4/6/2017 - 4/6/2017			
DWR Inspector	Sterling York			
Accompanied By	Jimmy Vantress Farmer

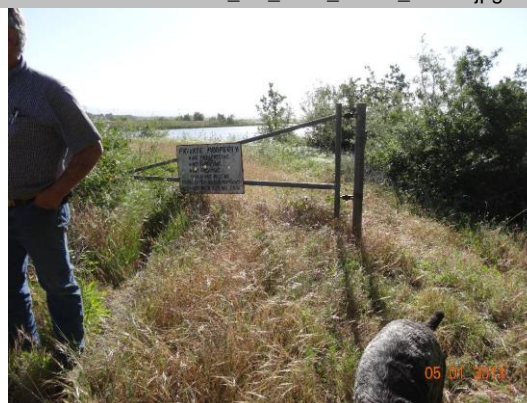
Photo 1 of 3 : UCIP_SP_2017_14731_24228.jpg

LM Start	0.01	Rating **	M	Issue No.	27
LM End	0.01	Issue Type +	Ma	Location *	N/A
Category	Supplemental			GPS Latitude/Longitude	
				Start	End
Item	DWR UCIP LMA Responsibility			39.298484 °	39.298484 °
				-121.569610 °	-121.569610 °
DWR ID					
Comment Code					
Inspector Comment					
FS_ID:14731					
DS_ID:19167					
EP_NO: N/A					
Repair Type: Non-Urgent					
Crossing Status: Found					
UCIP Comments: Dense vegetation on landward side obstructs inspection. Vegetation needs to be cleared to perform utility crossing inspection.					
FIELD_STRUCT_DESC: 24-inch corrugated metal drain pipe through the levee 12.0 feet below the crown. Flap gate on waterward end. Originally included the O&M manual, 1953.					
FS Date: 5/1/2013

View of crown looking east.

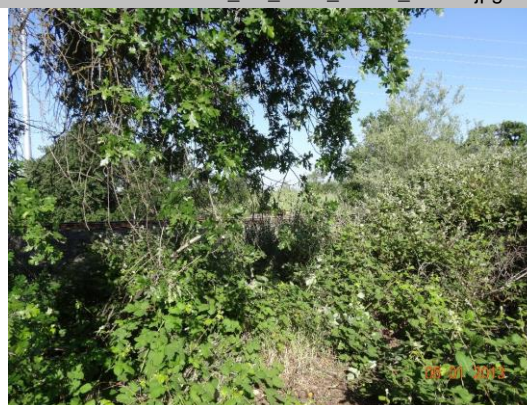
Photo 2 of 3 : UCIP_SP_2017_14731_24225.jpg

View of railroad looking west of crossing.

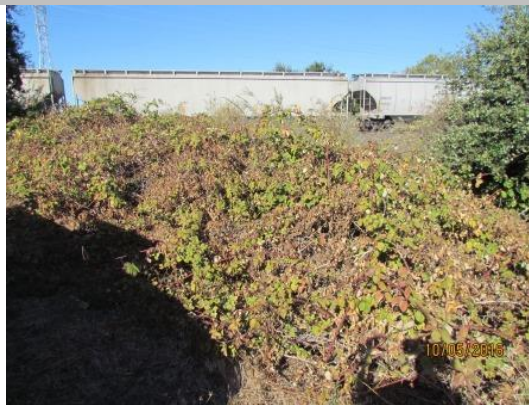
Photo 1 of 1 : SP_2017_NA0006_252_19_20170316_00008.jpg

LM Start	0.02	Rating **	U	Issue No.	19
LM End	0.02	Issue Type +	Ma	Location *	WS
Category	Earthen Levee			GPS Latitude/Longitude	
				Start	End
Item	Vegetation			39.298500 °	39.298500 °
				-121.569508 °	-121.569508 °
DWR ID	DWR_NA0006_01_f_2016_19				
Comment Code					
V2 : Remove the wild growth other than native grasses from the levee slopes.					
Inspector Comment					
Remove Blackberry bushes covering waterside levee slope.

View of Blackberry bushes covering waterside levee slope.

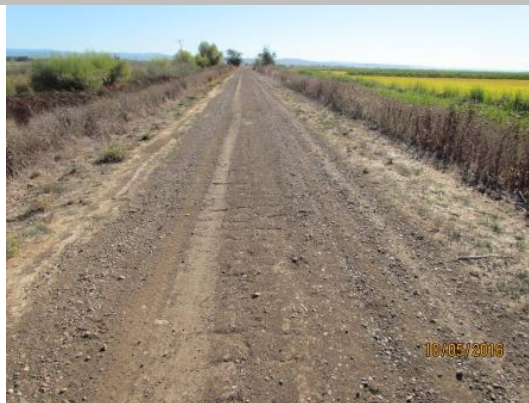
Photo 1 of 1 : SP_2017_NA0006_252_21_20170316_00010.jpg

LM Start	0.02	Rating **	U	Issue No.	21
LM End	0.66	Issue Type +	Ma	Location *	CR
Category	Earthen Levee			GPS Latitude/Longitude	
				Start	End
Item	Crown Surface / Depressions / Rutting			39.298504 °	39.297595 °
				-121.569502 °	-121.558310 °
DWR ID	DWR_NA0006_01_s_2015_21				
Comment Code					
C3 : Add appropriate gravel or road base. Grade and compact.					
Inspector Comment					
Place appropriate gravel on the crown roadway to make it an all weather road.

View of the crown looking upstream of a section of road that needs all weather surface. Fall 2016

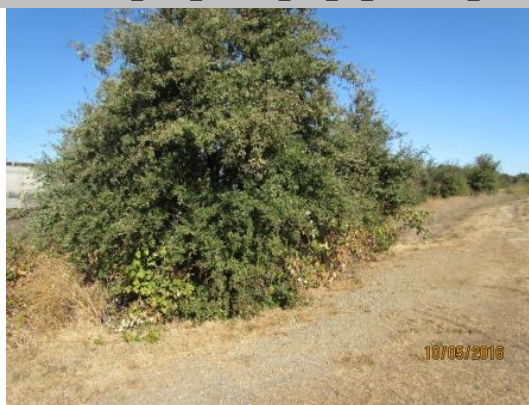
Photo 1 of 1 : SP_2017_NA0006_252_20_20170316_00009.jpg

LM Start	0.02	Rating **	U	Issue No.	20
LM End	0.02	Issue Type +	Ma	Location *	WS
Category	Earthen Levee			GPS Latitude/Longitude	
				Start	End
Item	Trim / Thin Trees			39.298563 °	39.298563 °
				-121.569432 °	-121.569432 °
DWR ID	DWR_NA0006_01_f_2016_20				
Comment Code					
T1 : Trim trees to at least five feet above ground level.					
Inspector Comment					
A tree that needs the limbs trimmed up 5' for visibility and access on the waterside. Fall 2016.

View of a tree that needs the limbs trimmed up 5' for visibility and access on the waterside. Fall 2016.

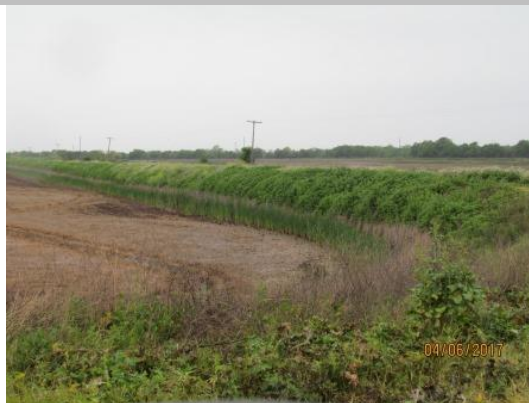
Photo 1 of 1 : SP_2017_NA0006_252_8_20170410_00034.jpg

LM Start	0.02	Rating **	U	Issue No.	8
LM End	0.67	Issue Type +	Ma	Location *	LS
Category	Earthen Levee			GPS Latitude/Longitude	
				Start	End
Item	Vegetation			39.298570 °	39.297562 °
				-121.569427 °	-121.558337 °
DWR ID	DWR_NA0006_01_s_2017_8				
Comment Code					
V2 : Remove the wild growth other than native grasses from the levee slopes.					
Inspector Comment					
Broad leaf thistle covering landside slope, Spring 2017.

View looking downstream of broad leaf thistle covering landside slope, Spring 2017.

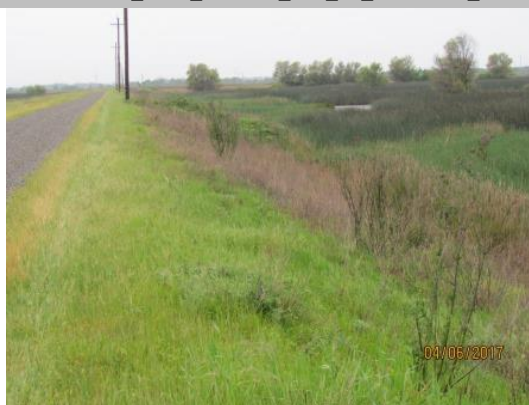
Photo 1 of 1 : SP_2017_NA0006_252_18_20170410_00033.jpg

LM Start	0.02	Rating **	M	Issue No.	18	
LM End	1.45	Issue Type +	Ma	Location *	WS	
Category	Earthen Levee			GPS Latitude/Longitude		
				Start	End	
Item	Vegetation			39.298570 °	39.295263 °	
				-121.569427 °	-121.546580 °	
DWR ID	DWR_NA0006_01_f_2016_18					
Comment Code						
V1 : Control annual grass and weeds on the levee slopes and easements.						
Inspector Comment						
Annual vegetation needs to be maintained. Spring 2017.

View looking downstream waterside of annual vegetation that needs to be maintained. Spring 2017.

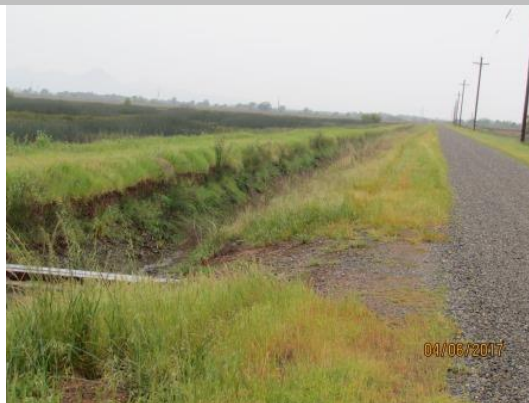
Photo 1 of 1 : SP_2017_NA0006_252_12_20170410_00032.jpg

LM Start	0.02	Rating **	M	Issue No.	12
LM End	1.45	Issue Type +	Ma	Location *	LS
Category	Earthen Levee			GPS Latitude/Longitude	
				Start	End
Item	Vegetation			39.298570 °	39.295263 °
				-121.569426 °	-121.546580 °
DWR ID	DWR_NA0006_01_f_2016_12				
Comment Code					
V1 : Control annual grass and weeds on the levee slopes and easements.					
Inspector Comment					
Annual vegetation needs to be maintained. Spring 2017.

View looking downstream landside of annual vegetation that needs to be maintained. Spring 2017.

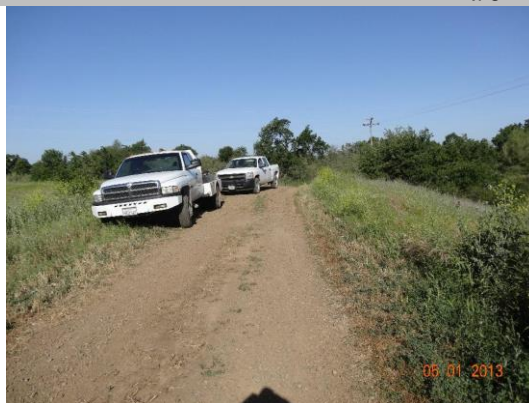
Photo 1 of 3 : UCIP_SP_2017_14732_24241.jpg

LM Start	0.09	Rating **	M	Issue No.	28
LM End	0.09	Issue Type +	Ma	Location *	LS
Category	Supplemental			GPS Latitude/Longitude	
				Start	End
Item	DWR UCIP LMA Responsibility			39.299106 °	39.299106 °
				-121.568749 °	-121.568749 °
DWR ID					
Comment Code					
Inspector Comment					
FS_ID:14732					
DS_ID:19168					
EP_NO: N/A					
Repair Type: Non-Urgent					
Crossing Status: Found					
UCIP Comments: Dense vegetation on waterward side and landward side obstructs inspection. Need to clear vegetation on slopes to conduct proper crossing evaluation.					
FIELD_STRUCT_DESC: 24-inch corrugated metal pipe through the levee 10 feet below the crown. Flap gate on the waterward end.					
Originally included in the O&M manual, 1953.					
FS Date: 5/1/2013

Overview of levee crown at crossing looking upstream.

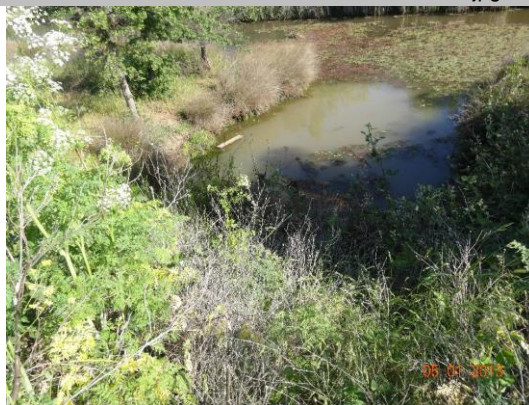
Photo 3 of 3 : UCIP_SP_2017_14732_24238.jpg

Overview of waterward side (outlet).

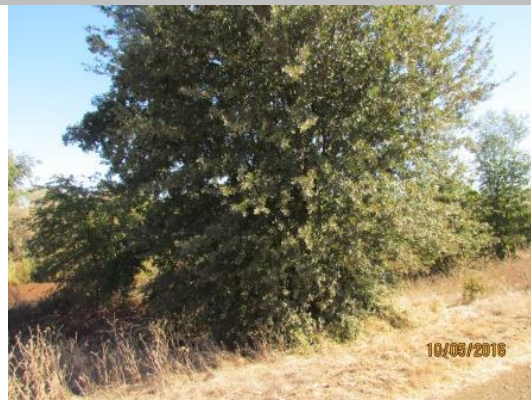
Photo 1 of 1 : SP_2017_NA0006_252_22_20170316_00011.jpg

LM Start	0.10	Rating **	M	Issue No.	22
LM End	0.10	Issue Type +	Ma	Location *	WS
Category	Earthen Levee			GPS Latitude/Longitude	
				Start	End
Item	Trim / Thin Trees			39.299078 °	39.299078 °
				-121.568633 °	-121.568633 °
DWR ID	DWR_NA0006_01_f_2016_22				
Comment Code					
T1 : Trim trees to at least five feet above ground level.					
Inspector Comment					
A tree that needs the limbs trimmed up 5' for visibility and access on the waterside. Fall 2016.

View of a tree that needs the limbs trimmed up 5' for visibility and access on the waterside. Fall 2016.

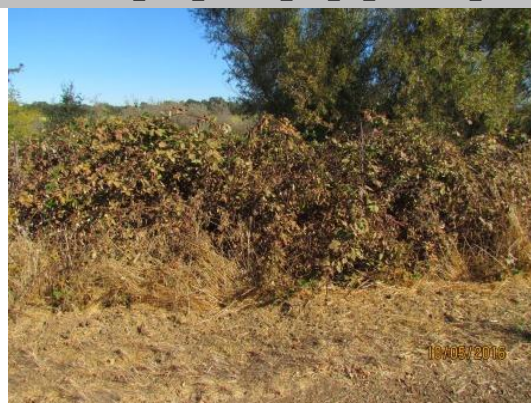
Photo 1 of 1 : SP_2017_NA0006_252_24_20170316_00013.jpg

LM Start	0.21	Rating **	U	Issue No.	24
LM End	0.24	Issue Type +	Ma	Location *	WS
Category	Earthen Levee			GPS Latitude/Longitude	
				Start	End
Item	Vegetation			39.298836 °	39.298768 °
				-121.566572 °	-121.565921 °
DWR ID	DWR_NA0006_01_f_2016_24				
Comment Code					
V2 : Remove the wild growth other than native grasses from the levee slopes.					
Inspector Comment					
Remove Blackberry bushes covering the waterside slope.

View of Blackberry bushes that cover the waterside slope. Fall 2016.

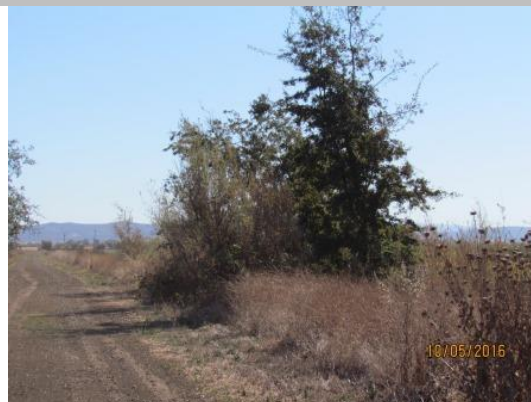
Photo 1 of 1 : SP_2017_NA0006_252_23_20170316_00012.jpg

LM Start	0.21	Rating **	U	Issue No.	23
LM End	0.21	Issue Type +	Ma	Location *	LS
Category	Earthen Levee			GPS Latitude/Longitude	
				Start	End
Item	Trim / Thin Trees			39.298816 °	39.298816 °
				-121.566529 °	-121.566529 °
DWR ID	DWR_NA0006_01_f_2016_23				
Comment Code					
T3 : Trim and thin trees to allow visibility of the ground and room to flood fight.					
Inspector Comment					
Trees that needs the limbs trimmed up 5' for visibility and access on the landside. Fall 2016.

View of trees that needs the limbs trimmed up 5' for visibility and access on the landside. Fall 2016.

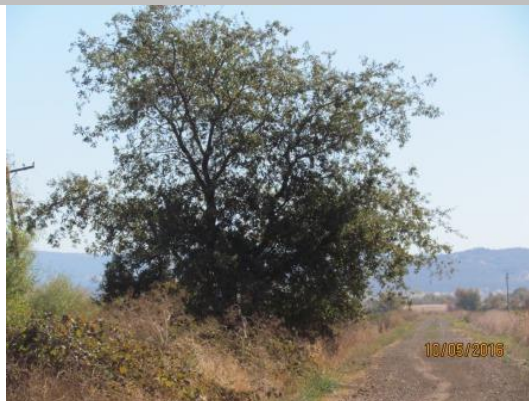
Photo 1 of 1 : SP_2017_NA0006_252_25_20170316_00014.jpg

LM Start	0.23	Rating **	M	Issue No.	25
LM End	0.23	Issue Type +	Ma	Location *	WS
Category	Earthen Levee			GPS Latitude/Longitude	
				Start	End
Item	Trim / Thin Trees			39.298776 °	39.298776 °
				-121.566158 °	-121.566158 °
DWR ID	DWR_NA0006_01_f_2016_25				
Comment Code					
T1 : Trim trees to at least five feet above ground level.					
Inspector Comment					
Tree that needs the limbs trimmed up 5' for visibility and access on the waterside. Fall 2016.

View of a tree that needs the limbs trimmed up 5' for visibility and access on the waterside. Fall 2016.

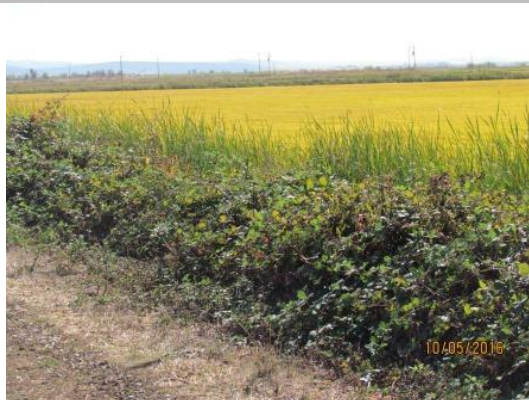
Photo 1 of 1 : SP_2017_NA0006_252_26_20170316_00015.jpg

LM Start	0.41	Rating **	U	Issue No.	26
LM End	0.41	Issue Type +	Ma	Location *	LS
Category	Earthen Levee			GPS Latitude/Longitude	
				Start	End
Item	Vegetation			39.298367 °	39.298367 °
				-121.562820 °	-121.562820 °
DWR ID	DWR_NA0006_01_f_2016_26				
Comment Code					
V2 : Remove the wild growth other than native grasses from the levee slopes.					
Inspector Comment					
Remove Blackberry bushes covering landside slope.

View of Blackberry bushes that cover the landside slope. Looking upstream. Fall 2016.

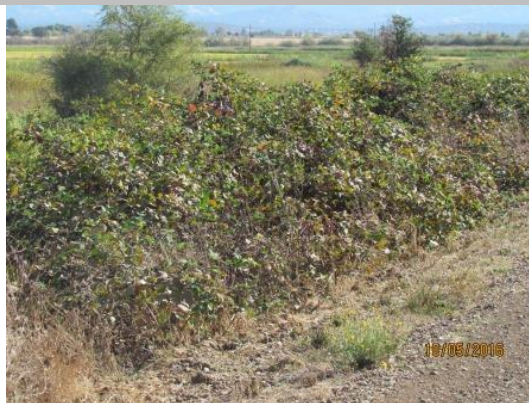
Photo 1 of 1 : SP_2017_NA0006_252_16_20170316_00004.jpg

LM Start	0.42	Rating **	U	Issue No.	16
LM End	0.45	Issue Type +	Ma	Location *	WS
Category	Earthen Levee			GPS Latitude/Longitude	
				Start	End
Item	Vegetation			39.298355 °	39.298280 °
				-121.562702 °	-121.562032 °
DWR ID	DWR_NA0006_01_f_2016_16				
Comment Code					
V2 : Remove the wild growth other than native grasses from the levee slopes.					
Inspector Comment					
Remove Blackberry bushes covering waterside slope.

View of Blackberry bushes that cover the waterside slope. Looking upstream. Fall 2016.

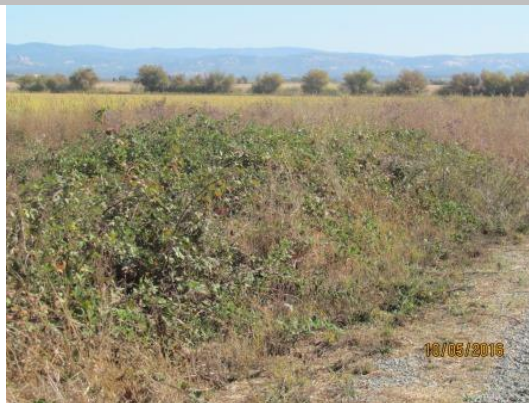
Photo 1 of 1 : SP_2017_NA0006_252_1_20170316_00001.jpg

LM Start	0.85	Rating **	M	Issue No.	1
LM End	0.96	Issue Type +	Ma	Location *	WS
Category	Earthen Levee			GPS Latitude/Longitude	
				Start	End
Item	Vegetation			39.294995 °	39.295021 °
				-121.557823 °	-121.555813 °
DWR ID	DWR_NA0006_01_f_2016_1				
Comment Code					
V2 : Remove the wild growth other than native grasses from the levee slopes.					
Inspector Comment					
Remove Blackberry bushes starting to take over waterside slope. Spring 2017.

View of Blackberry bushes that are starting to cover the waterside slope. Looking upstream. Fall 2016.

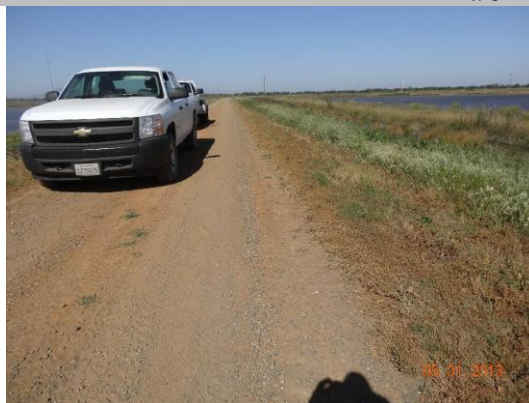
Photo 1 of 3 : UCIP_SP_2017_14733_24253.jpg

LM Start	0.98	Rating **	M	Issue No.	29
LM End	0.98	Issue Type +	En	Location *	WS
Category	Supplemental			GPS Latitude/Longitude	
				Start	End
Item	DWR UCIP Field Study			39.295026 °	39.295026 °
				-121.555440 °	-121.555440 °
DWR ID					
Comment Code					
Inspector Comment					
FS_ID:14733 DS_ID:19172 EP_NO: 9610 Repair Type: Non-Urgent Crossing Status: Found UCIP Comments: Scouring occuring directly across pipe on access road. Need to determine permit authorizing updates to crossing. Crossing appears to be no more than 10 years old. FIELD_STRUCT_DESC: 1 of 2: 24-inch corrugated metal irrigation pipe through the levee 6 feet below the crown. Slide gates are installed on waterward end of pipe (Permit No. 9610, 1974). Originally included in the O&M manual, 1953. FS Date: 5/1/2013

Overview of levee crown looking upstream at crossing.

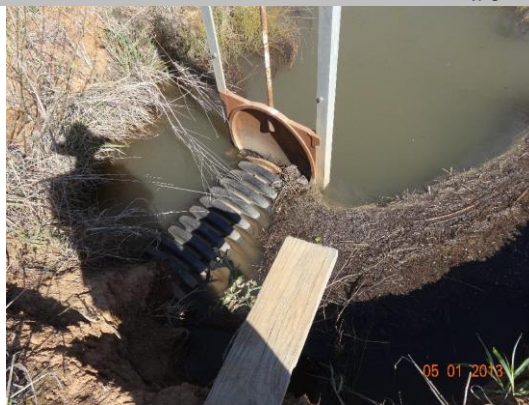
Photo 3 of 3 : UCIP_SP_2017_14733_24251.jpg

Positive closure device on waterward side.

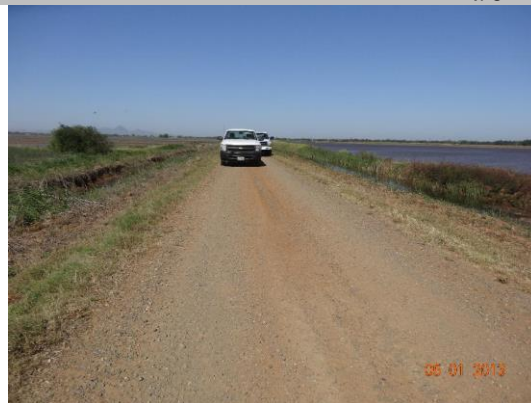
Photo 1 of 3 : UCIP_SP_2017_14734_24259.jpg

LM Start	1.17	Rating **	M	Issue No.	30
LM End	1.17	Issue Type +	En	Location *	WS
Category	Supplemental			GPS Latitude/Longitude	
				Start	End
Item	DWR UCIP Field Study			39.295099 °	39.295099 °
				-121.551839 °	-121.551839 °
DWR ID					
Comment Code					
Inspector Comment					
FS_ID:14734 DS_ID:19174 EP_NO: N/A Repair Type: Non-Urgent Crossing Status: Found UCIP Comments: Recent repair will need to contact owner to follow-up. FIELD_STRUCT_DESC: 24-inch corrugated metal pipe through the level 10 feet below the crown. Flapgate on waterward side. FS Date: 5/1/2013

Overview of levee crown looking upstream from crossing.

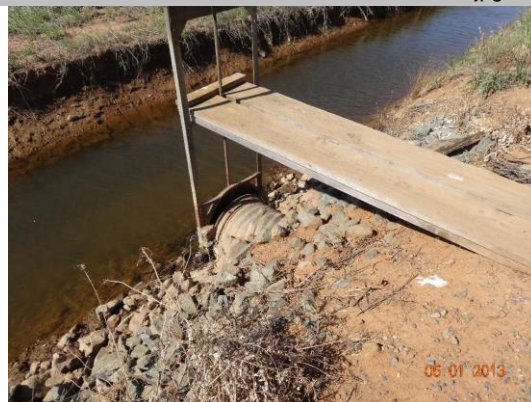
Photo 2 of 3 : UCIP_SP_2017_14734_24258.jpg

View of landward side: positive closure device, walkway, and rip rap on slope.

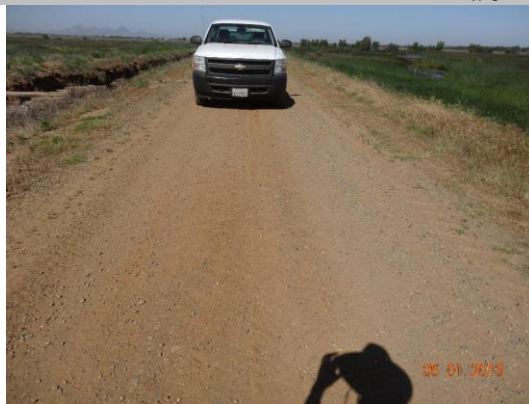
Photo 1 of 3 : UCIP_SP_2017_14736_24275.jpg

LM Start	1.44	Rating **	M	Issue No.	31
LM End	1.44	Issue Type +	En	Location *	WS
Category	Supplemental			GPS Latitude/Longitude	
				Start	End
Item	DWR UCIP Field Study			39.295238 °	39.295238 °
				-121.546755 °	-121.546755 °
DWR ID					
Comment Code					
Inspector Comment					
FS_ID:14736 DS_ID:19169 EP_NO: N/A Repair Type: Non-Urgent Crossing Status: Found UCIP Comments: Need to determine permit authorizing work. FIELD_STRUCT_DESC: 18-inch corrugated metal pipe through the levee 8 feet below the crown. Slide gate on the landward end. Shot rock revetment on the landside near slide-gate. FS Date: 5/1/2013

View of levee crown looking upstream at crossing.

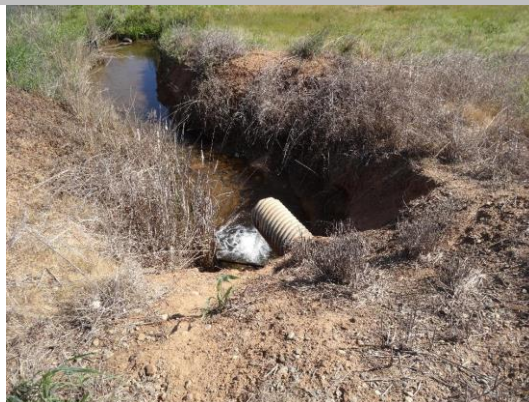
Photo 3 of 3 : UCIP_SP_2017_14736_24274.jpg

Crossing visible on waterward side.
